# Highways: The New Economics

## Volunteer Road Inspections

### Volunteer Inspection of Main Roads in Brackley

October 2023

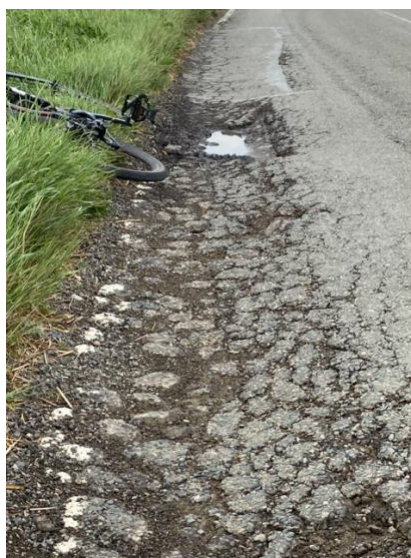
By contrast, the cycled survey of Radstone Road covered both directions at lower speeds, yet still highlighted how easily defects can be missed. For example, an 8 m long, 20 cm deep trench failure, missed during regular inspections, was identified and repaired within two weeks after being reported.

Significant degradation of road markings was also observed, with over two-thirds worn away. This reduces safety, particularly at night, and accelerates road edge deterioration due to vehicle overrunning.
