# Highways: The New Economics Story Of A Pothole

## The Story of a Pothole

# The Story of Radstone Road

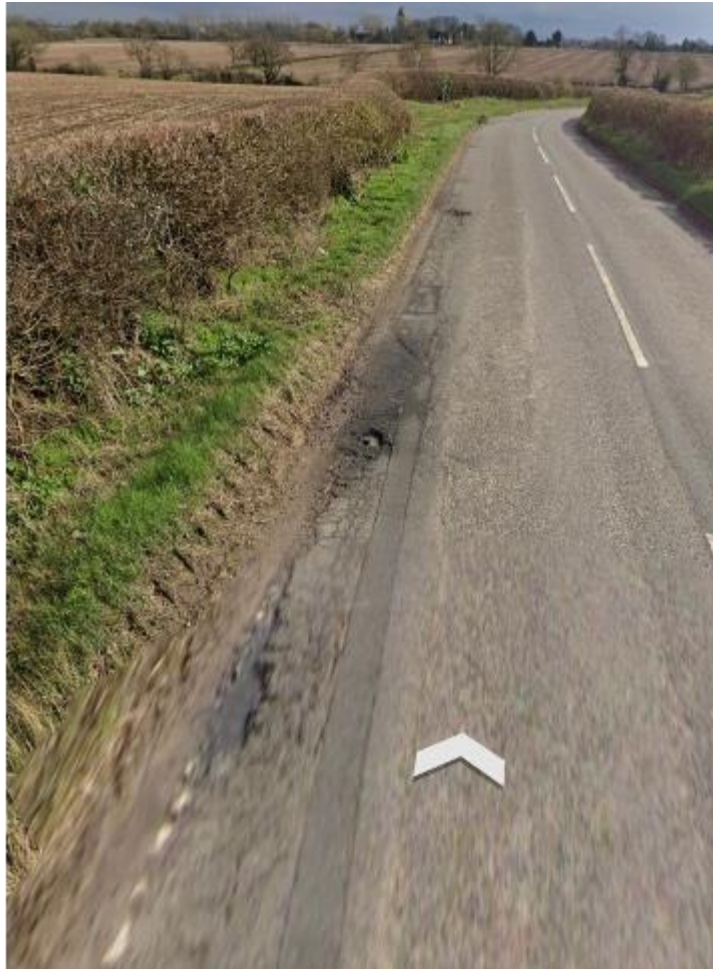
Less than seven years later, by April 2023, the same section had deteriorated dramatically.

The obvious question is: How can a road described as "well managed" decline from excellent condition to almost beyond repair in under seven years?

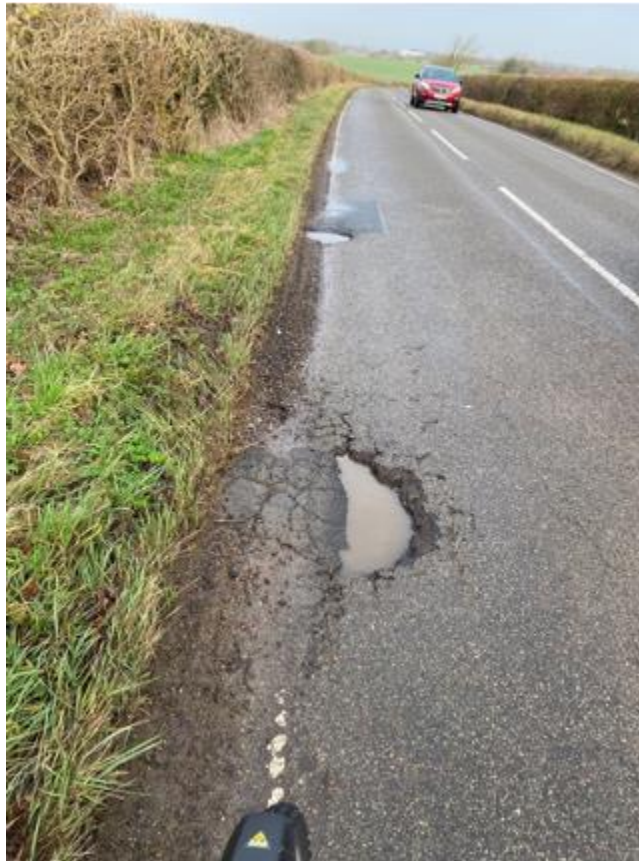
On 8 January 2020, just over three years after the 2016 Google Earth image, I reported it on FixMyStreet.

- The edge white lines had almost disappeared.
- Cracking had begun around the defect.
- Loose stone (scree) was visible along the drainage channel.
- Water was already entering the road.

Although the pothole had finally reached the intervention size, it was already too late to prevent further damage.

If repaired immediately after my January 2020 report, it would have required about 9,000cm<sup>3</sup>, already 30 times more.

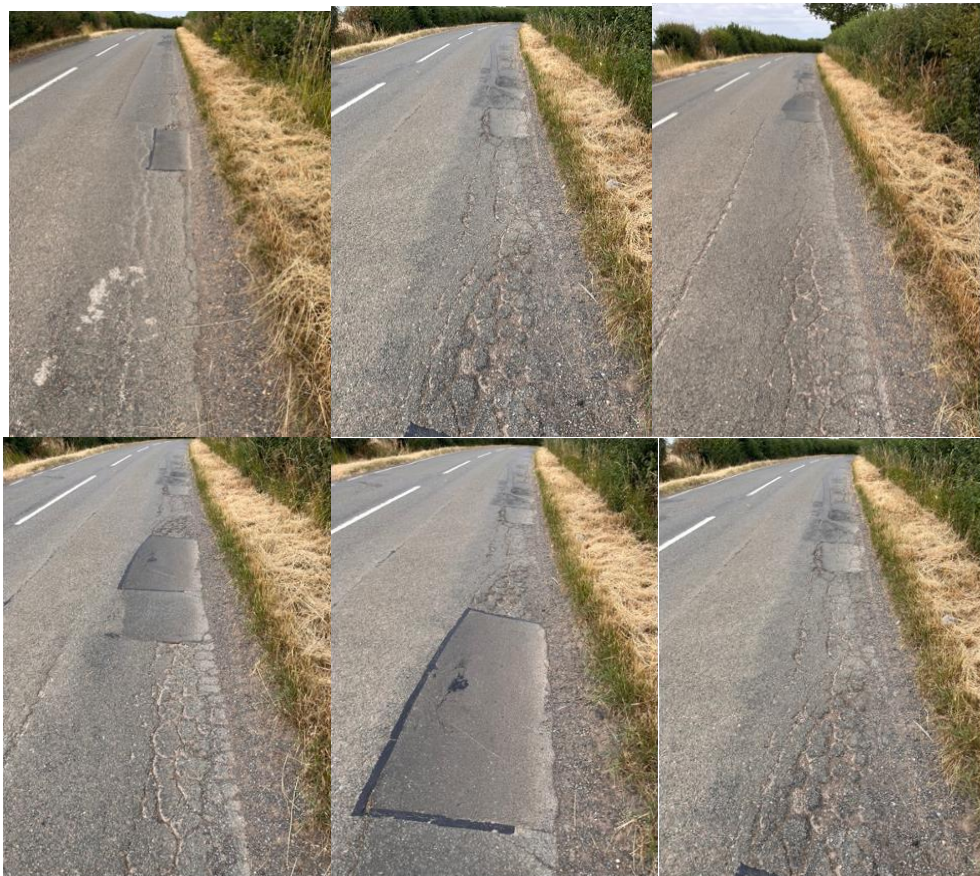
In July 2026, the damaged section extends for around 47 metres (see below images).

The road has widespread "crocodile cracking" and structural failure across much of the carriageway.

To rebuild this section properly would require approximately 4.2 million cm<sup>3</sup> of asphalt.
